FIBER OPTIC CABLE VULNERABILITY TEST, WHITE SANDS, NEW MEXICO

By S. F. LARGE G. W. STYSKAL

DECEMBER 1982

Project No. 4940
Prepared by
THE MITRE CORPORATION
Bedford, Massachusetts
Contract No. F19628-82-C-0001

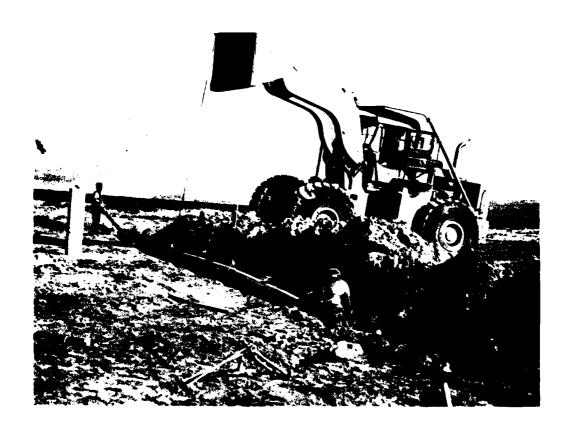
Figure 2. Trenching of Ductile Steel Conduit

The bare cable assemblies at each respective depth were laid in the trenches first and covered with 3 to 5 inches of a sand and gravel mixture. The conduit placements consisted of four 10-ft sections screwed together using their threaded matings (see figure 2). The ductile steel conduit had a 5-inch outside diameter with a vinyl clad
